**INVESTIGATION OF MAXIMUM  
TEMPERATURES ATTAINED BY  
PLASTIC FUEL GAS PIPE INSIDE  
SERVICE RISERS**

**TR-30**

**2010**

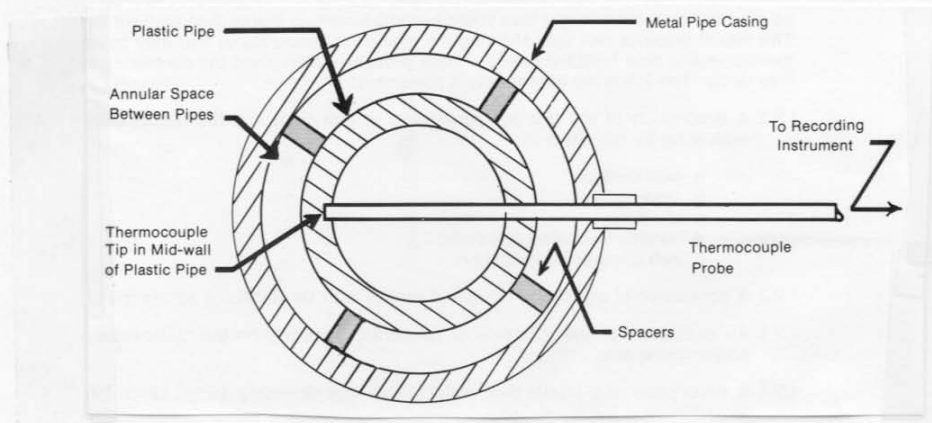
Figure 1. Top Cross-Sectional View of Plastic Pipe in Metal Casing Showing Thermocouple Arrangement

- 3.2 The assembly included a thermocouple with the sensing element at the mid-wall of the plastic pipe. A continuous strip-chart recorder measured the temperature. Figure 1 shows a cross section of the assembly, in which the thumbscrews are identified as spacers. Two of these complete test assemblies were used for tests that were carried out at various locations throughout the United States. Figure 2 is a photograph of a typical test arrangement, showing both test assemblies and the recorder.

- 3.1 The assemblies used for these tests consisted of 3-foot pipe lengths of 3/4-inch IPS polyethylene pipe installed in a 1-1/4-inch metal pipe. The two ends of the plastic pipe were stoppered and the ends of the metal pipe were capped. The plastic pipe was secured in the metal pipe by thumbscrews, so the annular space could be maintained at about 1/6 inch at all points and the plastic did not touch the metal pipe. By adjusting the thumbscrews, the plastic pipe could be brought into contact with the metal pipe when desired.

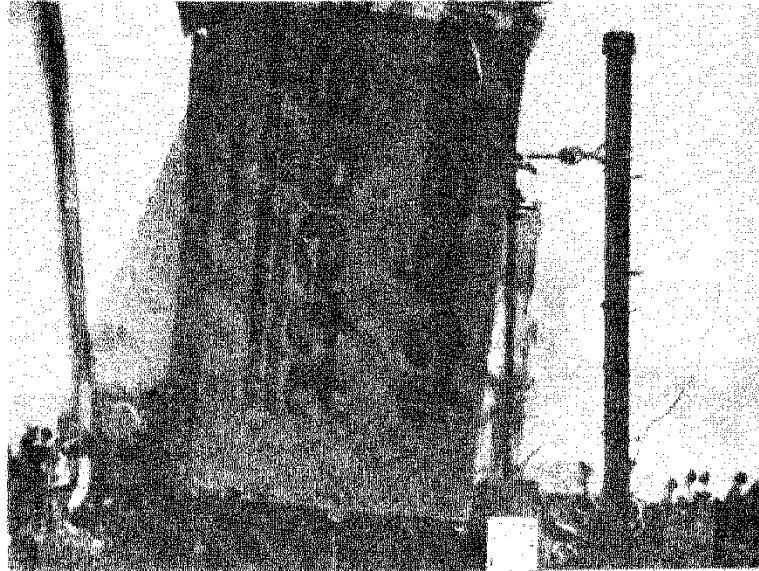
**Figure 3. Arrangement of Test Assemblies and Recorder with One Test Assembly Shaded and One Unshaded**

- 4.2 The effect of shading** - A definite temperature reduction of the plastic pipe was obtained by shading the assembly. With one assembly shaded, its temperature was approximately 10°F lower than that of the unshaded assembly. Figure 3 is a photograph showing the arrangement in which one assembly is shaded and the other is exposed to the sun.

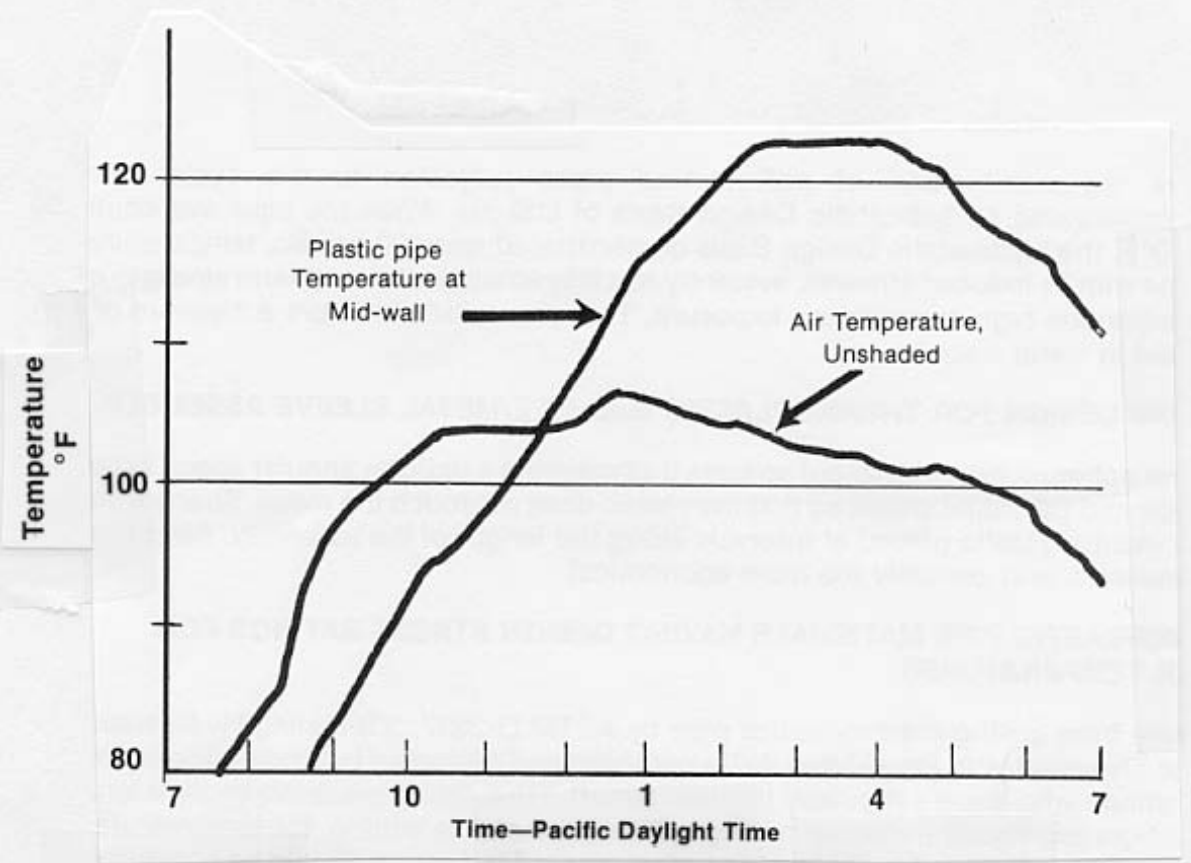
Figure 4. Air Temperature in Sun, and Temperature of Plastic Pipe in Standard Test Assemblies when Unshaded and Located on South Side of White Building in Southern California in July

- 5.2 A typical air temperature vs. plastic pipe temperature relationship is shown in Figure 4. A number of such relationships were used to arrive at the observations listed in 5.1 above.

5.1 A correlation has been established between the ambient air temperature and the plastic pipe temperature in the simulated meter riser device, placed in stringent summertime environments. The value of this correlation is that it permits estimation of the number of hours the pipe will be above 120°F or above 100°F from a knowledge of the air temperature vs. time plot. Following are several such relationships:

- 5.1.1 When the air temperature is between 100°F and 105° F for 7-1/2hours, the temperature of the plastic pipe will be above 120° F for 2-1/2hours.
- 5.1.2 When the air temperature is between 100°F and 102°F for 3 hours, the temperature of the plastic pipe will be above 120°F for 1 hour.
- 5.1.3 If the air temperature is less than 100°F, the plastic pipe temperature will not reach 120°F.
- 5.1.4 If the air temperature is below 80°F, the plastic pipe temperature will not reach 100°F.
- 5.1.5 Air temperatures between 80°F and 99°F will probably cause the plastic pipe temperature to exceed 100°F. The pipe temperature will likely be above 100°F for about one-third of the daylight hours that the air temperature is between 80°F and 99°F.
