Durability and Reliability of Large Diameter HDPE Pipe for Water Main Applications

Web Report #4485

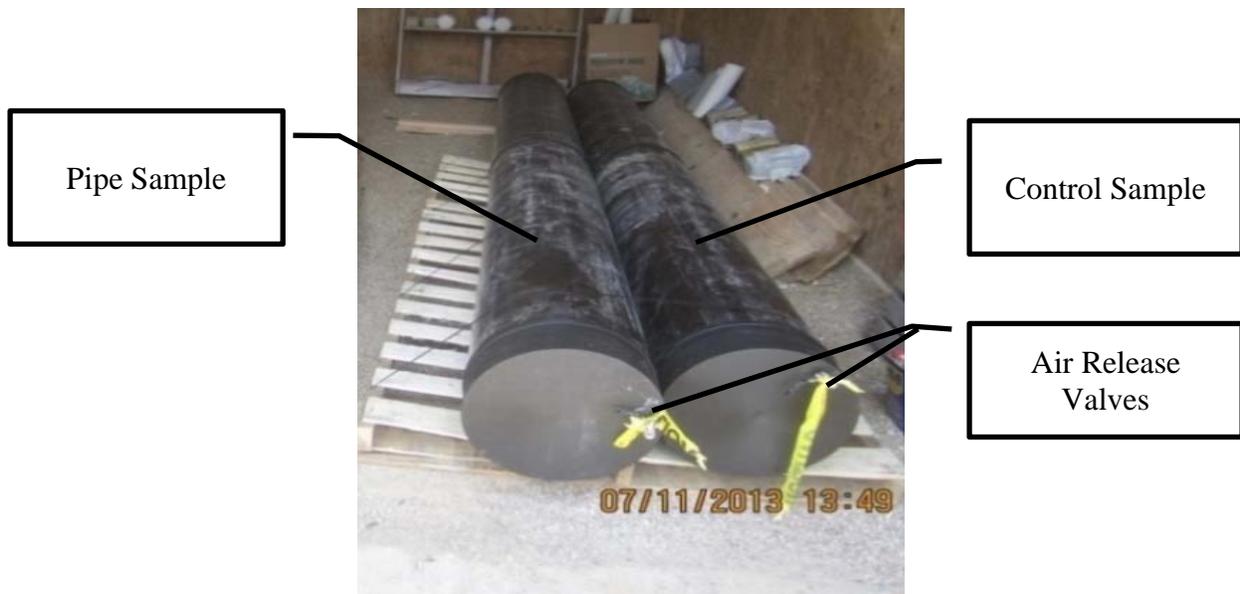
Figure 5.1 HDPE samples¹⁷

This section describes the experimental setup and role of each device. The setup comprised of a 450-gallon water reservoir, a multi-stage centrifugal pump (10 HP), a data acquisition system, a control board, several pressure transducers, a DC power supply, one pipe sample (16 in. diameter), one control pipe sample, and control valves including one back-flow pressure valve, two solenoid/pressure ball valves, and two butterfly valves. A galvanized steel piping system with pipe diameters of one in. and 2 in. connected the equipment. Physical properties of PE4710 HDPE such as modulus of elasticity and its viscoelastic nature to consider expansion, contraction and long-term loading impact to calculate discharge, increase in temperature, and head-loss were considered while designing the test setup. Figure 5.1 shows the pipe sample and the control sample. Figure 5.2 illustrates a schematic diagram of experimental setup. Refer to Appendix C for description of testing equipment.

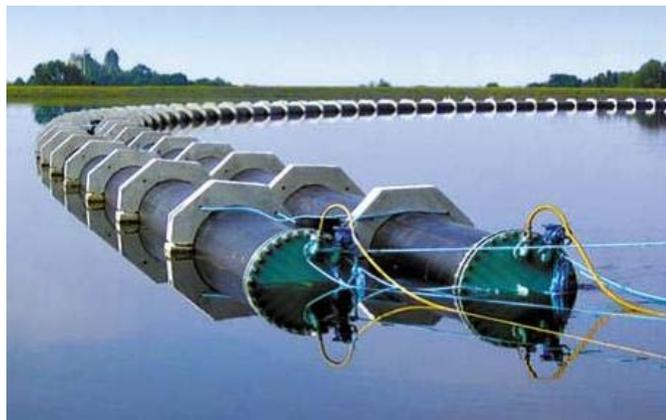
Figure 6.3 A part of the Katrine Lake pipeline spanned a reservoir. Fused pipe segments were sunk down the reservoir using anchoring weights

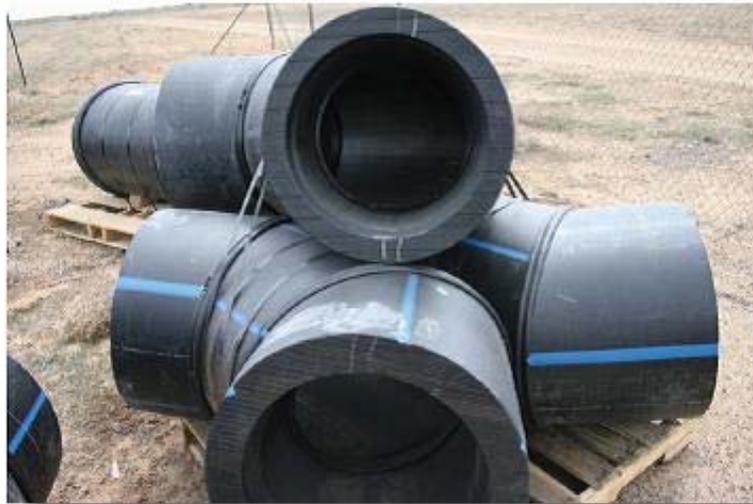
Figure 6.4 Sample fused fittings used for the Eastern Navajo HDPE transmission main

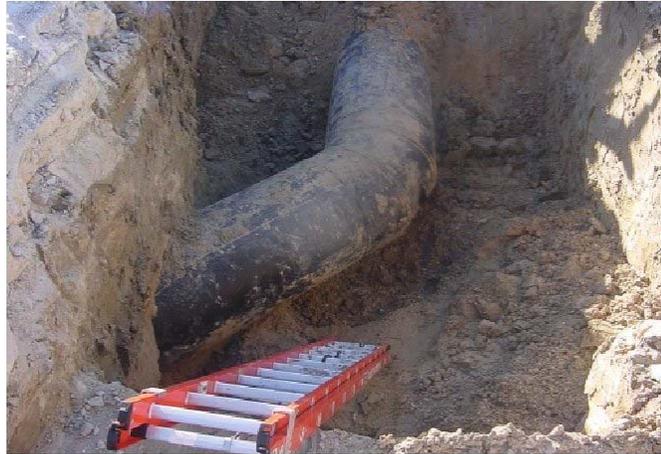
Figure 6.6 45-deg bend used in the Houston pilot study

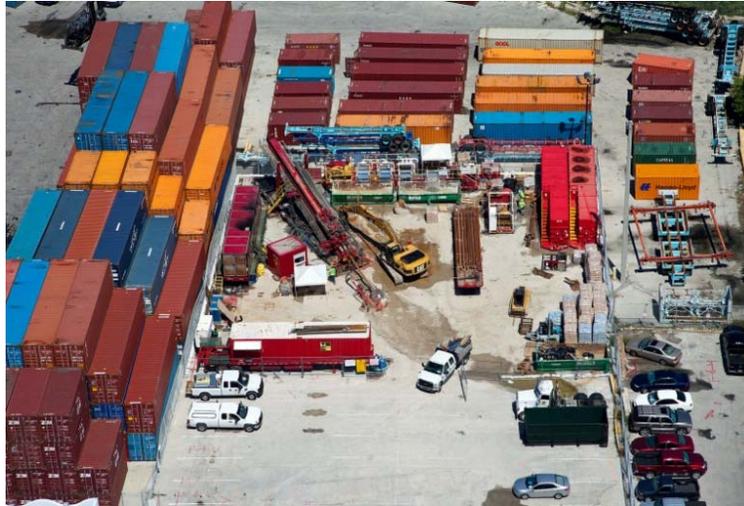
Figure 6.7 Aerial view of the drill rig used to install the 20 in. HDPE transmission main to Fisher Island

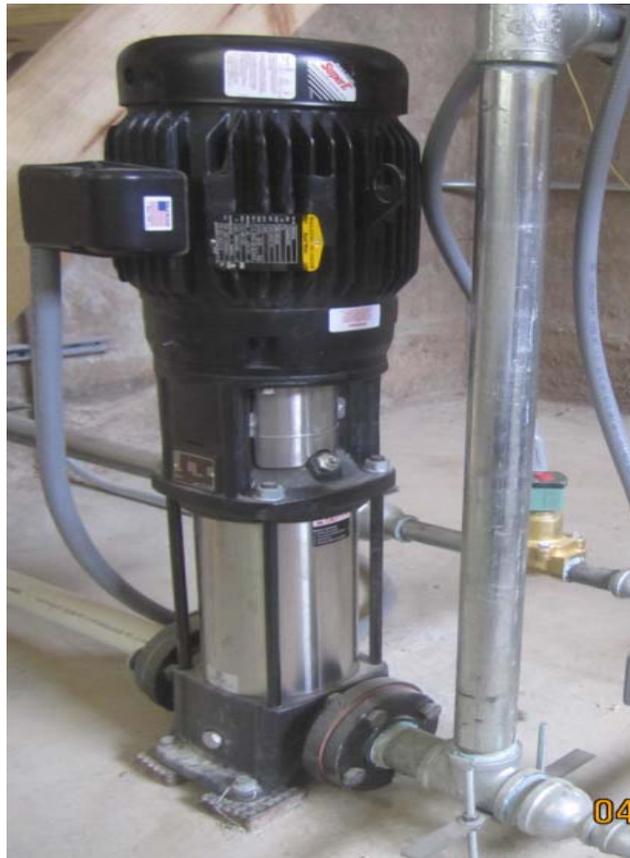
Figure C.2.6 Multi-stage centrifugal pump (10 HP)

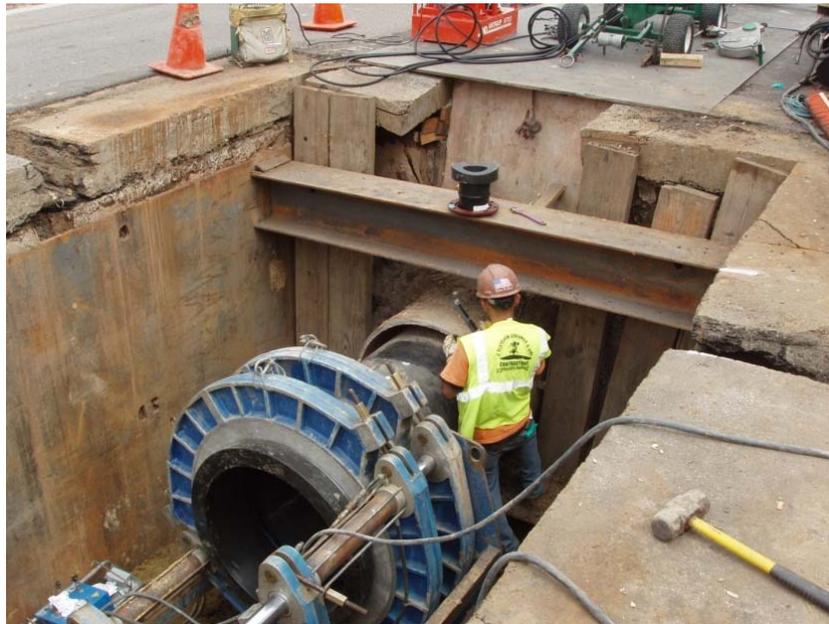
Figure D.1.2 Fusing the joints in the trench imposed a challenge for the construction crew

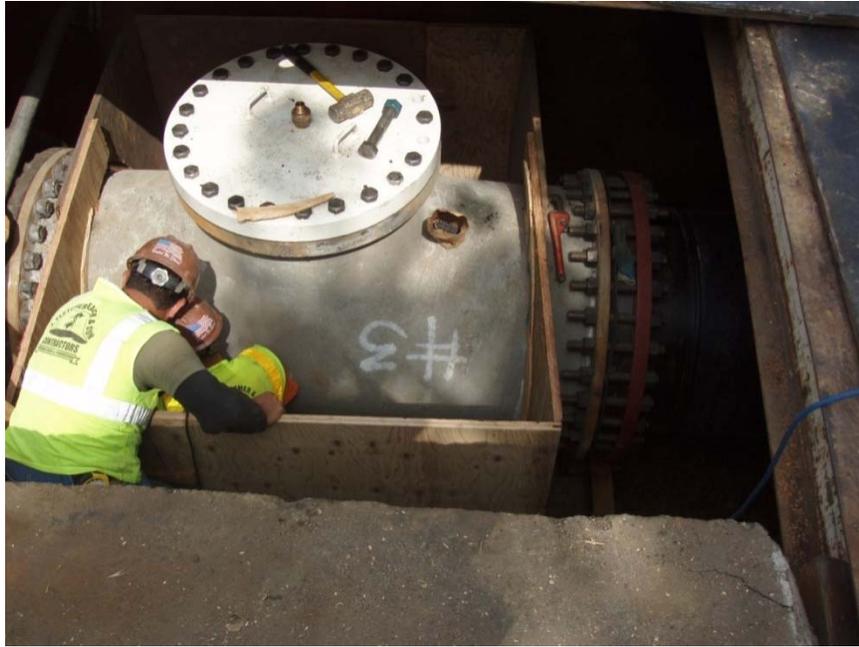
Figure D.1.4 Flanged tee connected to the new HDPE pipe

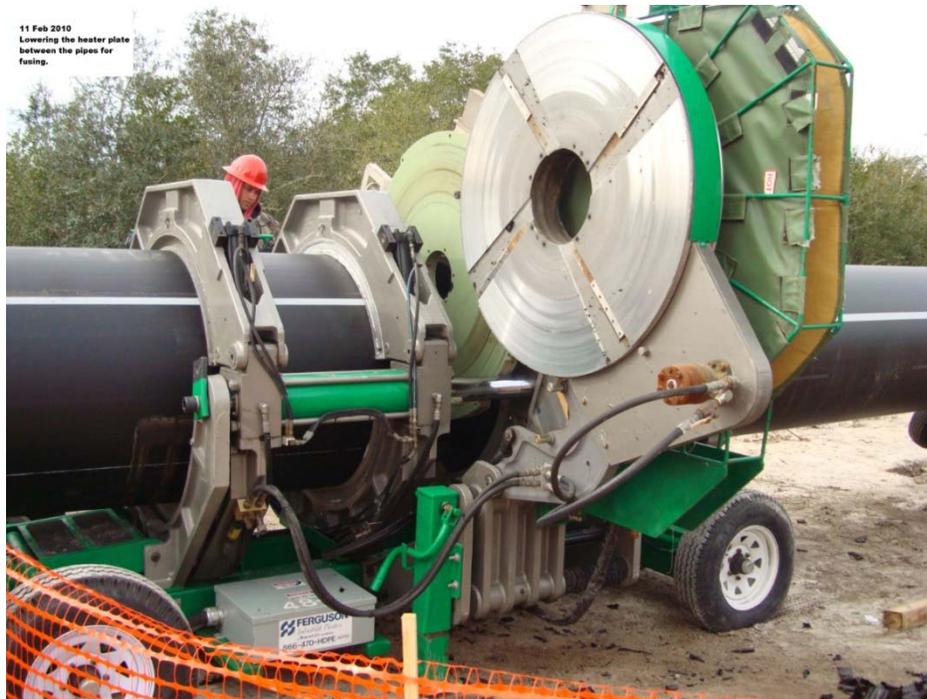
Figure D.2.5 Lowering the heater plate between the pipes for fusing

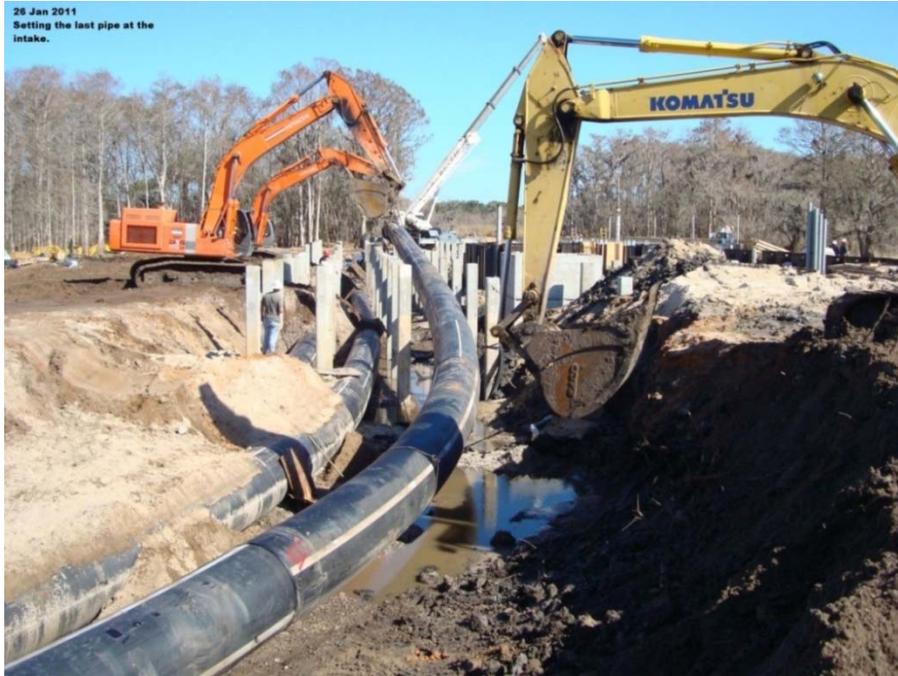
Figure D.2.8 Final pipe bend and tie-in

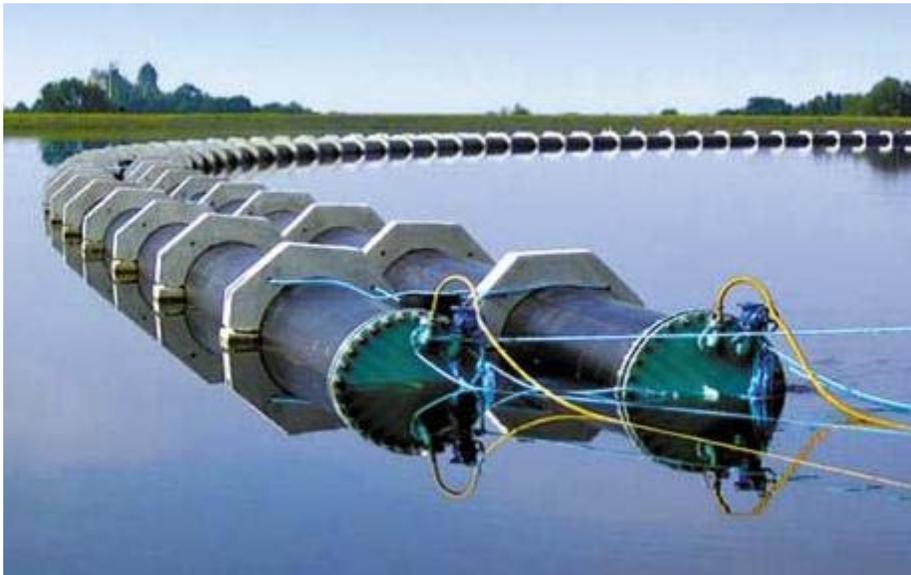
Figure D.3.1 A part of the Katrine Lake pipeline spanned a reservoir and fused pipe segments were sunk down the reservoir using anchoring weigh

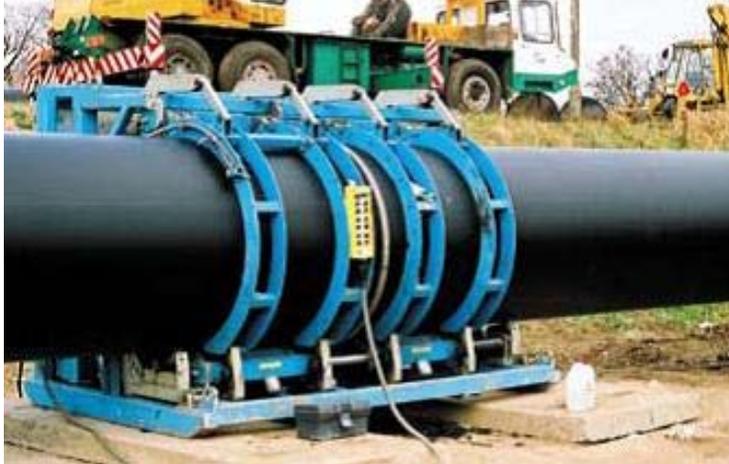
Figure D.3.2 Hot tool butt fusion machine by welding contractor, A.G. Wilson, with (HDPE) PE 100 pipe segments made from Hostalen CRP 100 black

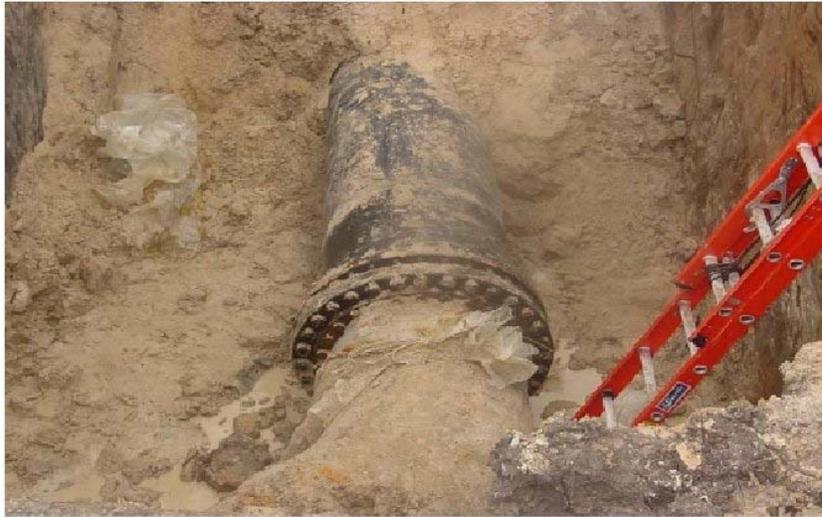
Figure D.5.1 Flanged connection between the 30 in. HDPE and bar wrapped concrete pressure pipe

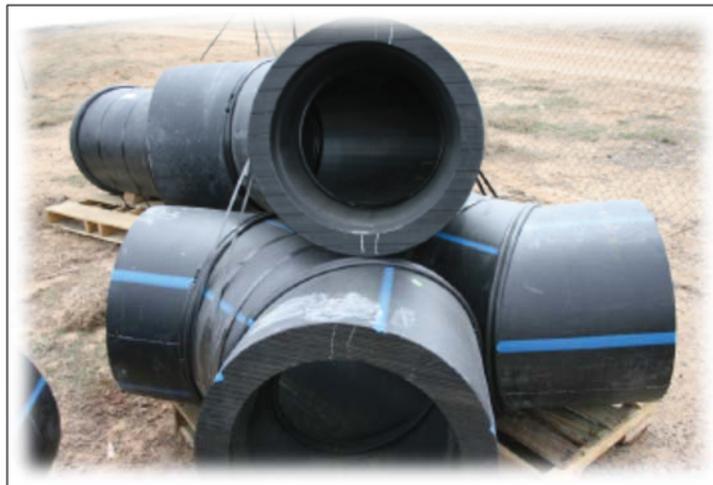
Figure D.6.1 Sample fused fittings used for the Navajo transmission main project

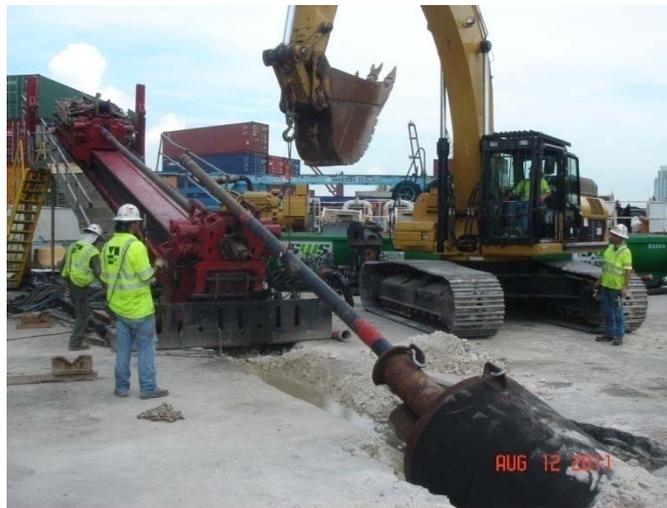
Figure D.8.1 HDD Pilot hole drill with starter casing
