**INVESTIGATION OF BENZENE
IN DRINKING WATER FOLLOWING
THE “CAMP FIRE” IN PARADISE, CA**

TR-51

2020

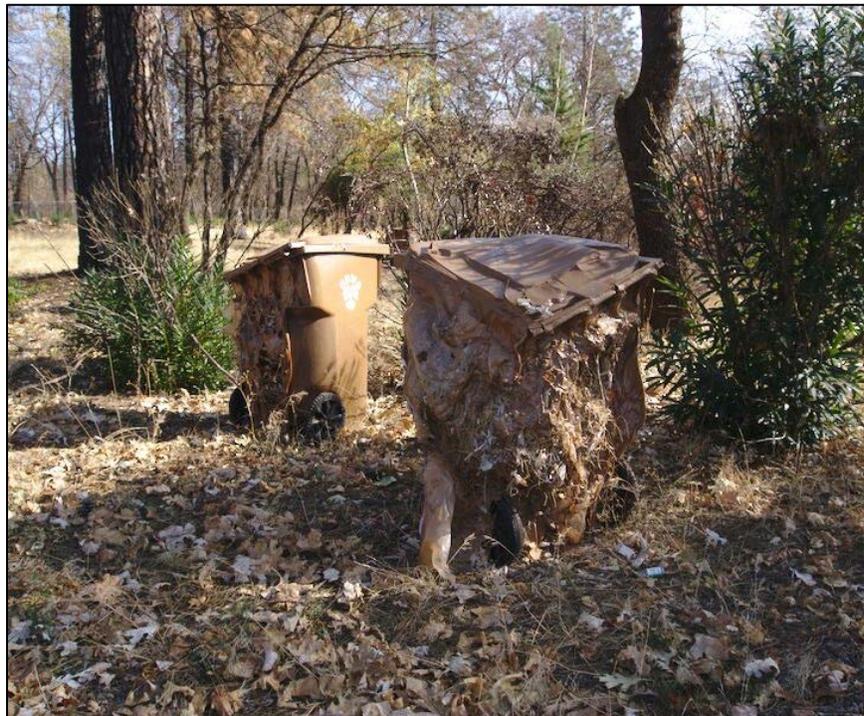
Figure 2: Yard waste bins partially melted by radiant heat from nearby house fire

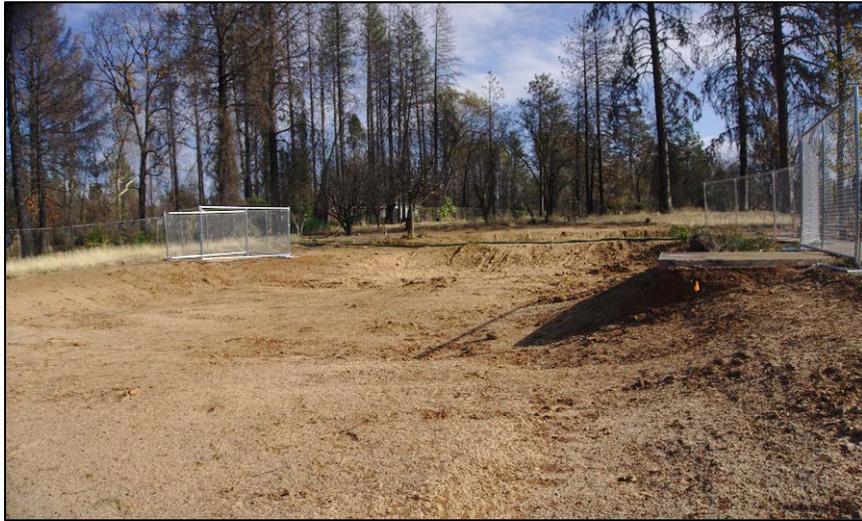
Figure 3: Site of a home after the fire; house debris and soil are removed

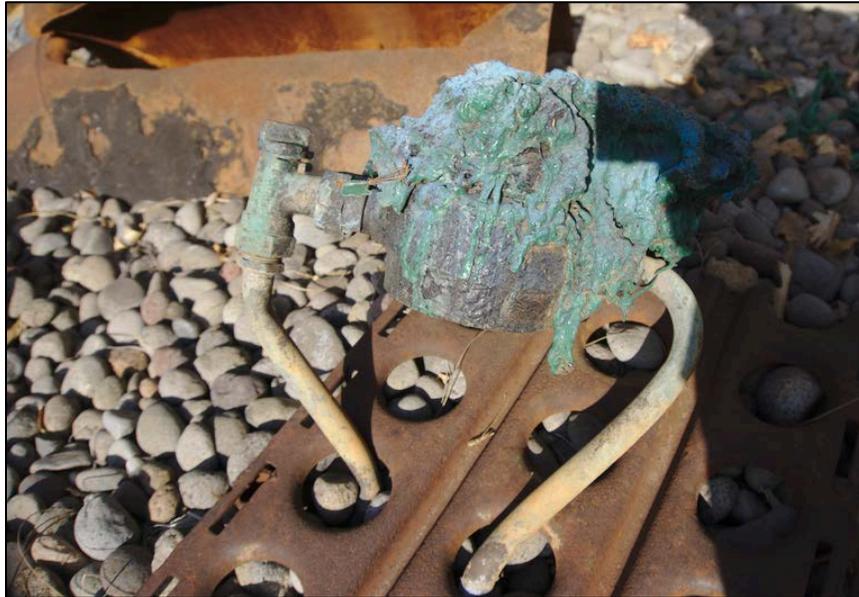
Damage to multiple points of the municipal system (curb boxes, house risers or plumbing systems) occurred as the fire consumed buildings, exposed piping and connections, and damaged some water meters. See **Figure 4**. Some pipelines are reported to have been open to the atmosphere for several weeks after the fire.

Figure 4: Damaged water meter

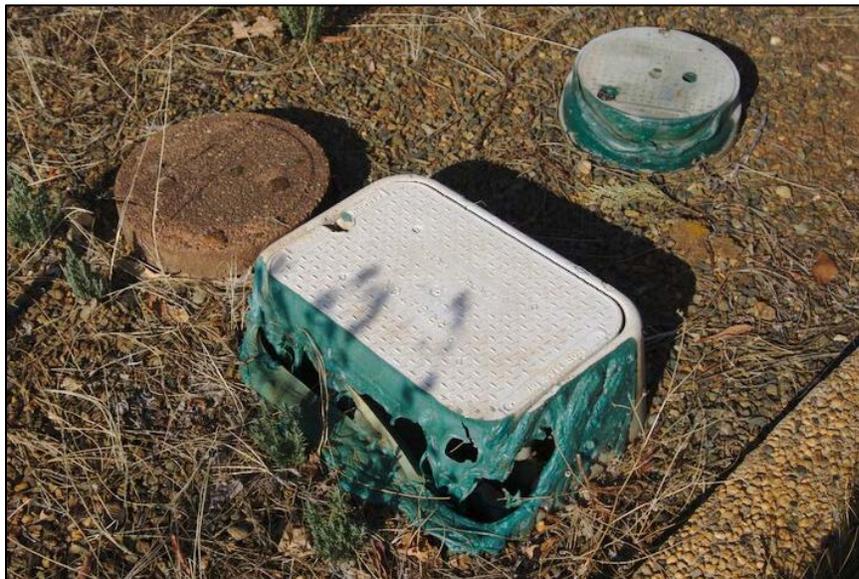
The intensity of the heat damaged both exposed metal and plastic pipes, as well as water meter boxes buried on-grade, with evidence of melted brass connections and corroded steel pipes. **See Figures 5 and 6.**

Figure 5: Partially melted meter box

Plastic curb boxes frequently melted and may have ignited, dripping on components below, and particularly onto meters, possibly igniting the meter and/or other components within the curb box. Seats/seals of brass valves were damaged.

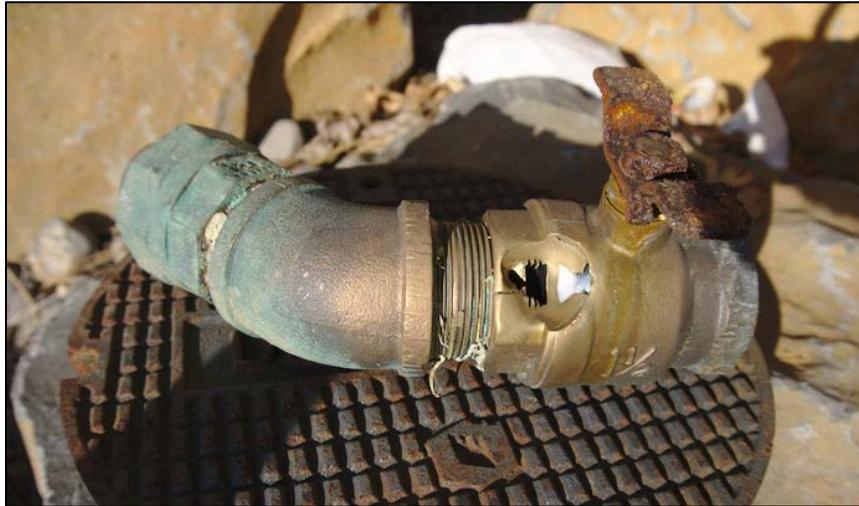
Figure 6: Brass water valve that is partially melted

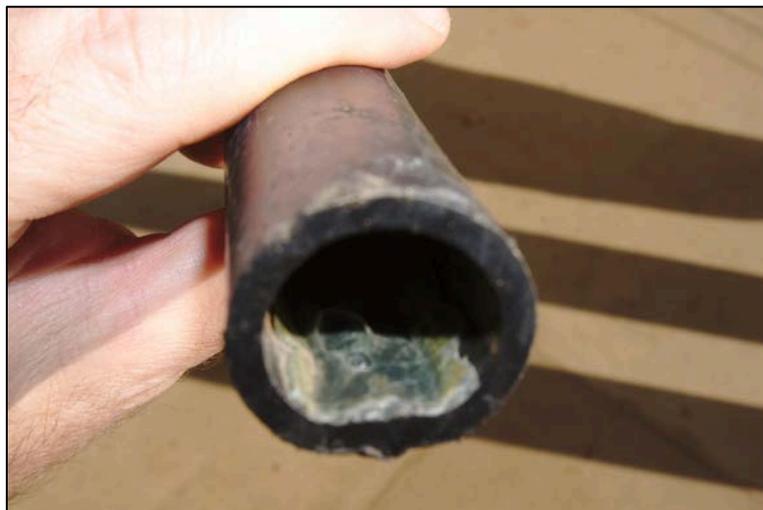
Some HDPE service lines had melted material deposits left within them from other materials; see **Figure 7**. It is presumed that these deposits were from a nearby fitting, meter or curb box. Where exposed to direct heat/fire, some plastic lines melted or burned.

Figure 7: HDPE water pipe with melted material deposits

Utilities and customers should consider replacing contaminated water service lines with new pipes (e.g., HDPE conforming to AWWA C901, PEX conforming to AWWA C904) when flushing does not eliminate contamination.
