**INVESTIGATION OF BENZENE
IN DRINKING WATER FOLLOWING
THE “CAMP FIRE” IN PARADISE, CA**

TR-51

2020

The purpose of this technical report is to report on PPI's investigation into reports of benzene in drinking water following the "Camp Fire" in Paradise, CA.

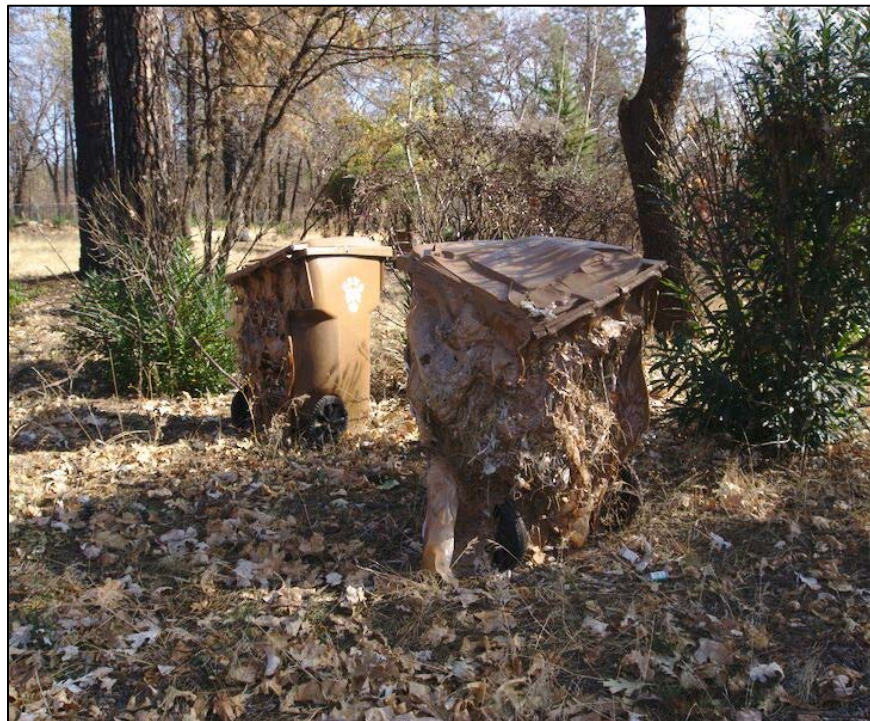
Figure 2: Yard waste bins partially melted by radiant heat from nearby house fire

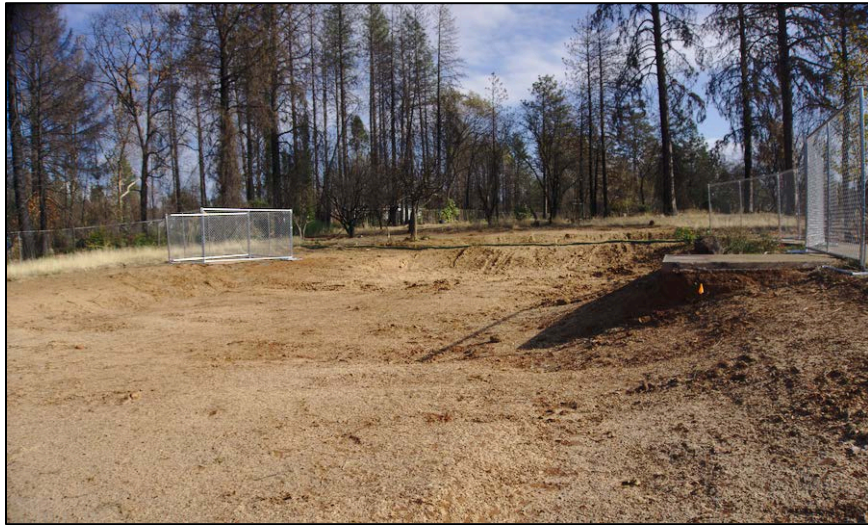
Figure 3: Site of a home after the fire; house debris and soil are removed

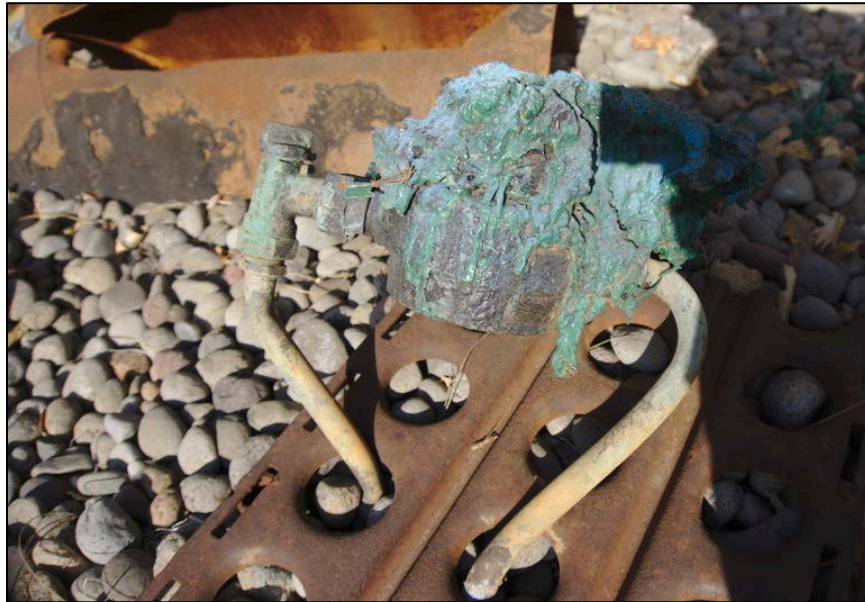
Damage to multiple points of the municipal system (curb boxes, house risers or plumbing systems) occurred as the fire consumed buildings, exposed piping and connections, and damaged some water meters. See **Figure 4**. Some pipelines are reported to have been open to the atmosphere for several weeks after the fire.

Figure 4: Damaged water meter

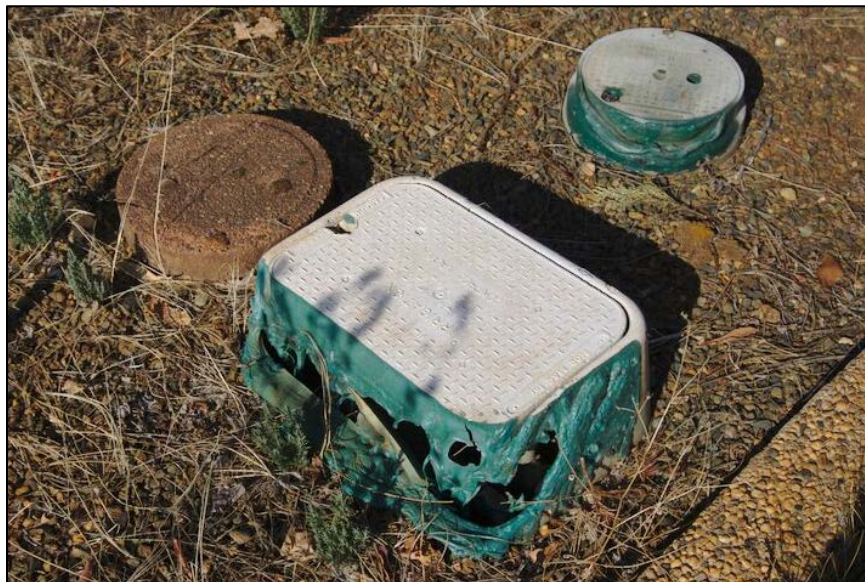
The intensity of the heat damaged both exposed metal and plastic pipes, as well as water meter boxes buried on-grade, with evidence of melted brass connections and corroded steel pipes. **See Figures 5 and 6.**

Figure 5: Partially melted meter box

Plastic curb boxes frequently melted and may have ignited, dripping on components below, and particularly onto meters, possibly igniting the meter and/or other components within the curb box. Seats/seals of brass valves were damaged.

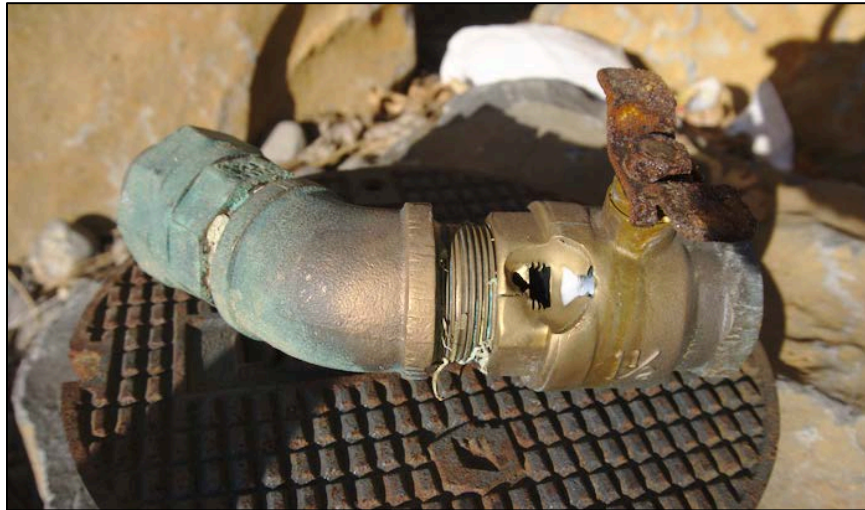
Figure 6: Brass water valve that is partially melted

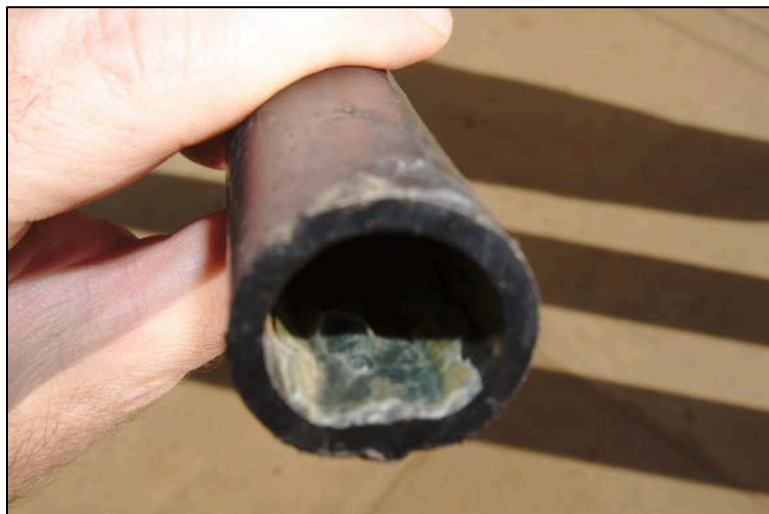
Some HDPE service lines had melted material deposits left within them from other materials; see **Figure 7**. It is presumed that these deposits were from a nearby fitting, meter or curb box. Where exposed to direct heat/fire, some plastic lines melted or burned.

Figure 7: HDPE water pipe with melted material deposits

Utilities and customers should consider replacing contaminated water service lines with new pipes (e.g., HDPE conforming to AWWA C901, PEX conforming to AWWA C904) when flushing does not eliminate contamination.
