TESTING COMPLETED FOR CORRUGATED HDPE PIPE IN SHALLOW COVER RAILROAD APPLICATIONS

*157-Ton Rail Cars Used in
Study of 48-Inch Diameter Corrugated Pipe;
Report Now Available*

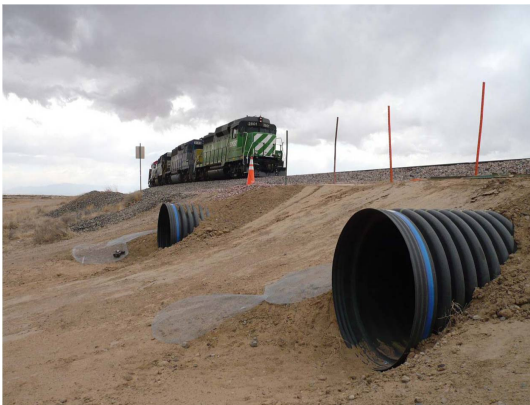
Pipe Installation

The pipes were installed in two adjacent locations in a fill on the High Tonnage Loop (HTL) at FAST.

The HTL is the 2.7-mile test loop where HAL tests are conducted at FAST. It is comprised of various curved, spiral, and tangent test sections. The height of the fill facilitated excavation and allowed access to both ends of the pipes after installation. There is no water flow at the fill location, and the pipes remained dry for the duration of the test. The pipes were installed 50 feet apart, center-to-center. The variable between the two sites was the composition and preparation of the backfill material. The excavations were sloped to comply with OSHA regulations.

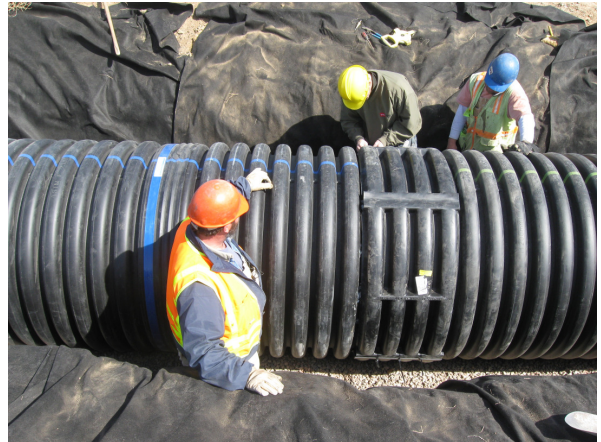
ADS constructed its standard watertight (WT) inline bell spigot joint, and its standard fabric wrapped split coupler connection for each pipe. The connections in each pipe were placed just outside the centerline of the rails. Pipe installation followed standards outlined in ASTM D2321 and in the study.
