HDPE Pipe Brings Life Back to Miami-Dade Water System

Property Protected and Narrow Work Area Problem Solved With Pipe Splitting Technique; Old Water Lines New Again

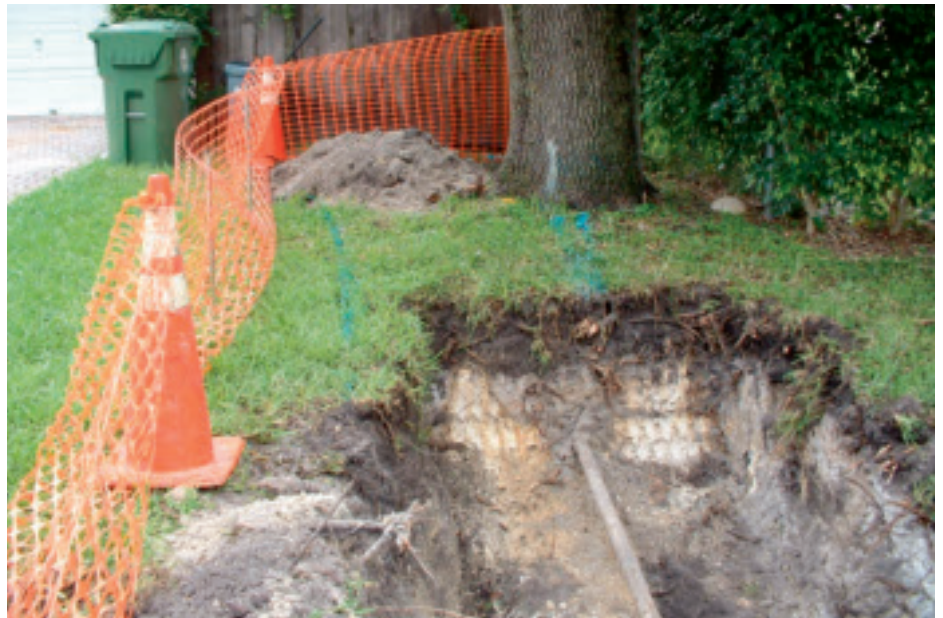
The old galvanized metal pipe provides a path for the new HDPE pipe to follow. The Miami-Dade crew excavates a small hole, inserts metal rods to break the old pipe and pulls the new HDPE pipe back through.

Once the area for reclamation is determined, the smallest trench possible is dug and the galvanized pipe cut and split. Rods are inserted and pushed through the old pipe. At the end of the run, HDPE pipe is fed through and

pulled back.

“In the trench, we feed the 1-meter long rods through the old pipe and hook into the cutter with an expanding cone that splits the pipe and knocks down any sharp edges inside the pipe. Then the HDPE pipe is hooked up at the other end and pulled back.”

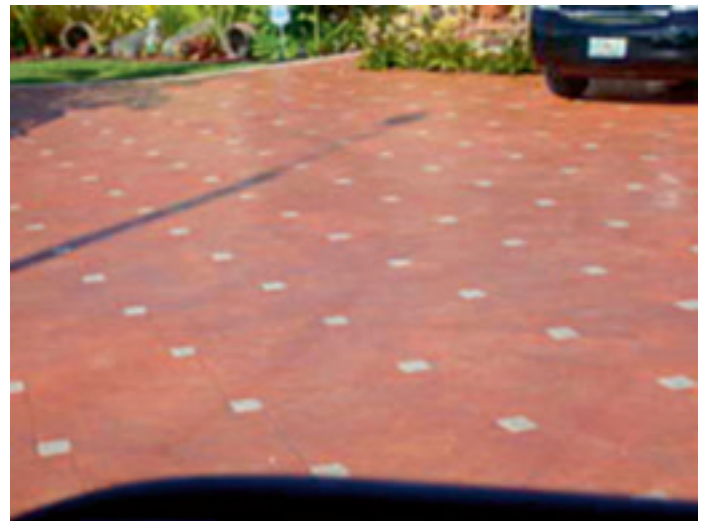
Intricately designed, patterned and art-deco driveways are highly prized by Miami-Dade homeowners. In order to save them, the water department threads the much-needed new 2-inch HDPE water pipeline under the pavement and yards, which also saved time and labor costs.

In Miami there are many art deco driveways. Homeowners decorate their driveways with poured, colored and tinted concrete and they won't allow Miami-Dade to rip up it up, even to provide better water service.
