Chlorine Resistance Testing of Cross-Linked Polyethylene Piping Materials

P. Vibien, J. Couch and K. Oliphant, Jana Laboratories Inc., Aurora, ON

Abstract

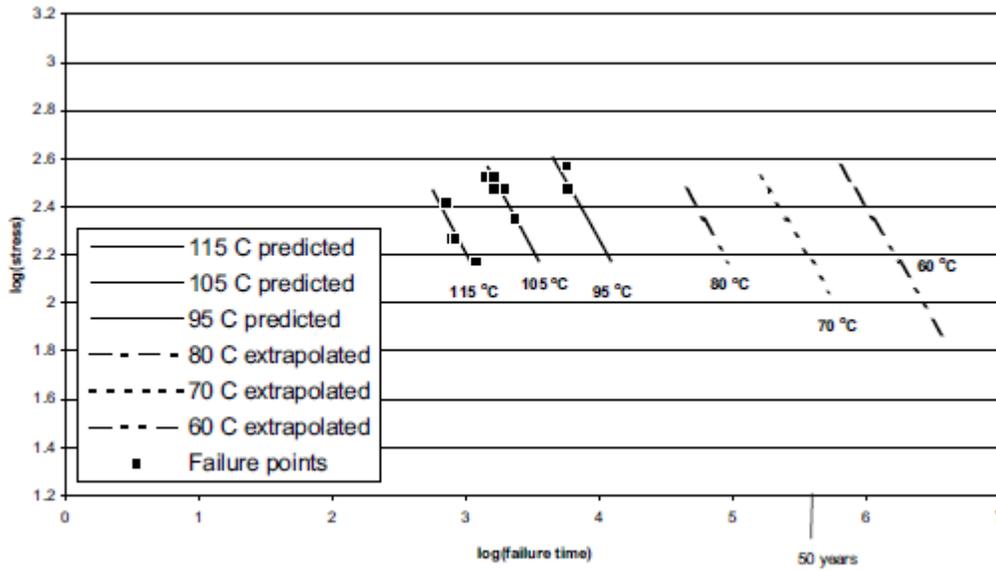
Figure 5: Failure Times for a PEX Pipe Material Exposed to Chlorinated Potable Water

Figure 5 shows a plot of the experimental failure points and the predicted failure times from the Rate Process Model. From the data it is seen that the Rate Process Model provides a good fit to the experimental data. The R² for the regression was 0.98. Also shown in Figure 5 are the extrapolated test lifetimes at lower temperatures.

For domestic plumbing applications the commonly accepted most aggressive end use conditions are 80 psi internal pressure and 60°C (140°F) temperature. In actual application both pressure and temperature, or the combination thereof, would be expected to be below these values. Moreover, most domestic plumbing systems do not experience continuous hot water conditions. These conditions would appear, therefore, to be relatively conservative. The extrapolated test lifetime for the PEX material tested based on these conditions is 93 years with a 95% lower confidence limit of 52 years. This estimate is based on testing at aggressive water quality conditions as well as extrapolation to aggressive end use conditions. Even though the presence of the chlorine in the potable water reduces the anticipated performance lifetime of the PEX pipe material tested, the material still appears to have very good chlorine resistance.
