Erosion Study on Brass Insert Fittings Used in PEX Piping Systems

TN-26

2014

EROSION STUDY ON BRASS INSERT FITTINGS USED IN PEX PIPING SYSTEMS

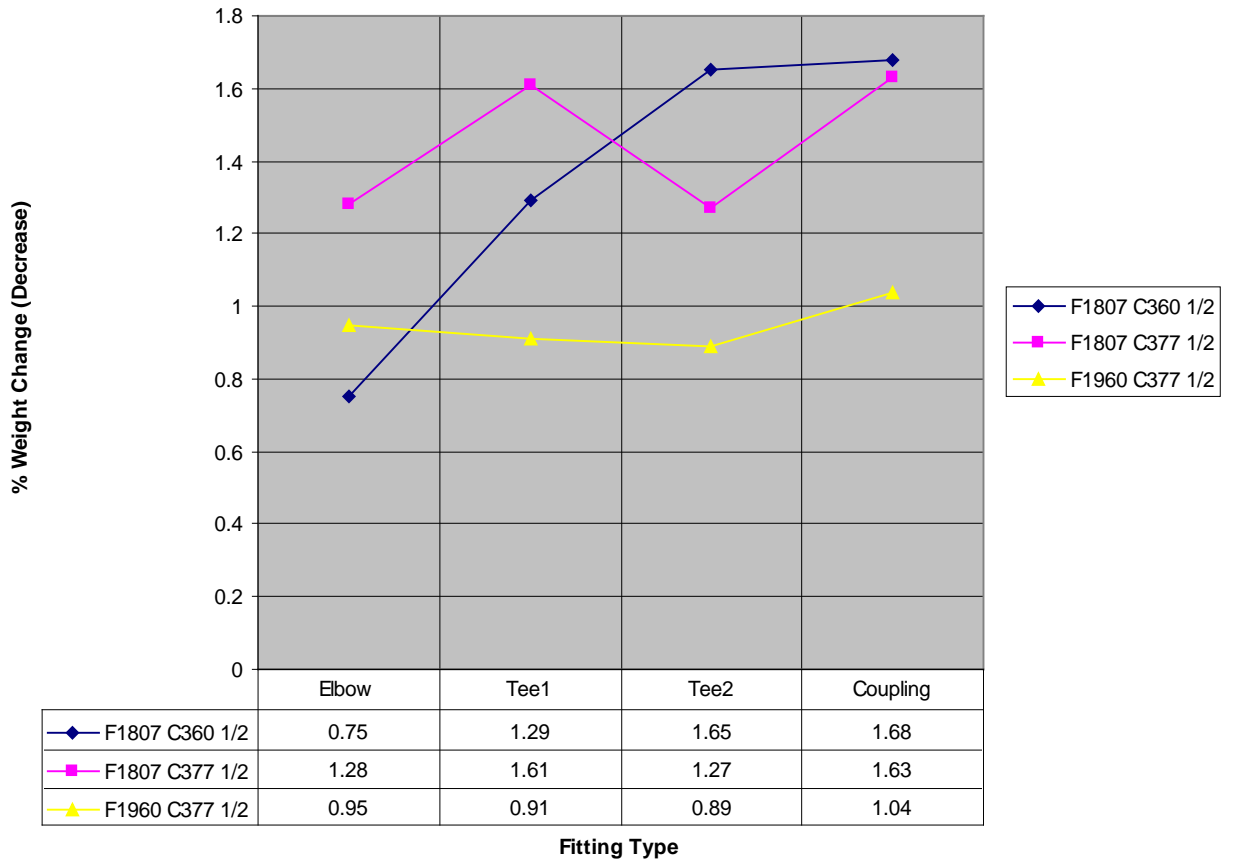
% Weight Loss vs Fitting Type 1/2" 1400250 Gallons - Table 3

Table 1	Weight loss of 3/4" fittings at end of test.
Table 2	Weight loss versus gallons of flow through 3/4" elbows.
Table 3	Weight loss of 1/2" fittings at end of test.
Table 4	Weight loss of 3/8" fittings at end of test.

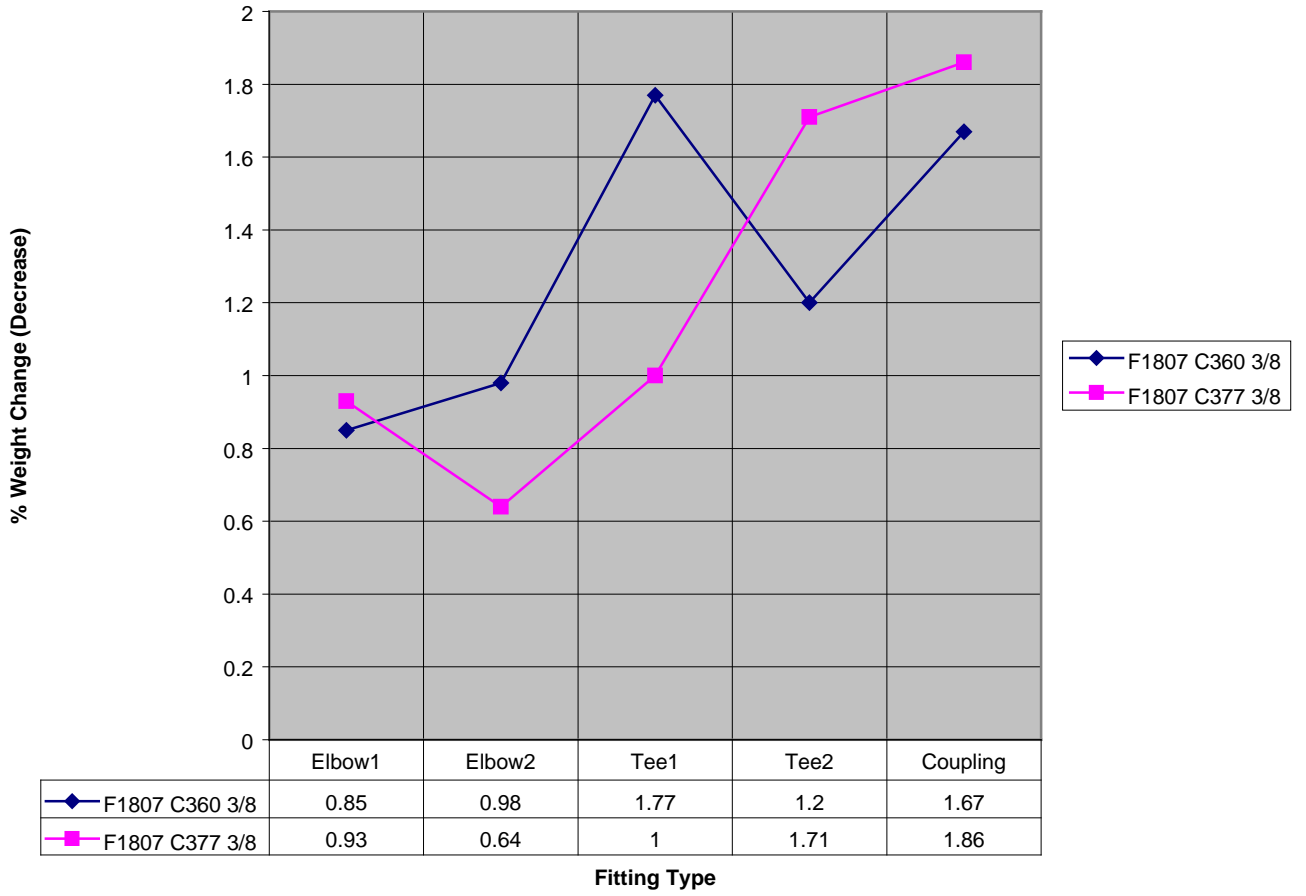
% Weight Loss vs Fitting Type 3/8" Fittings 700125 Gallons - Table 4

Table 4 does not have any 3/8" fitting data from F1960 type fittings because they were not available at the time of the test.

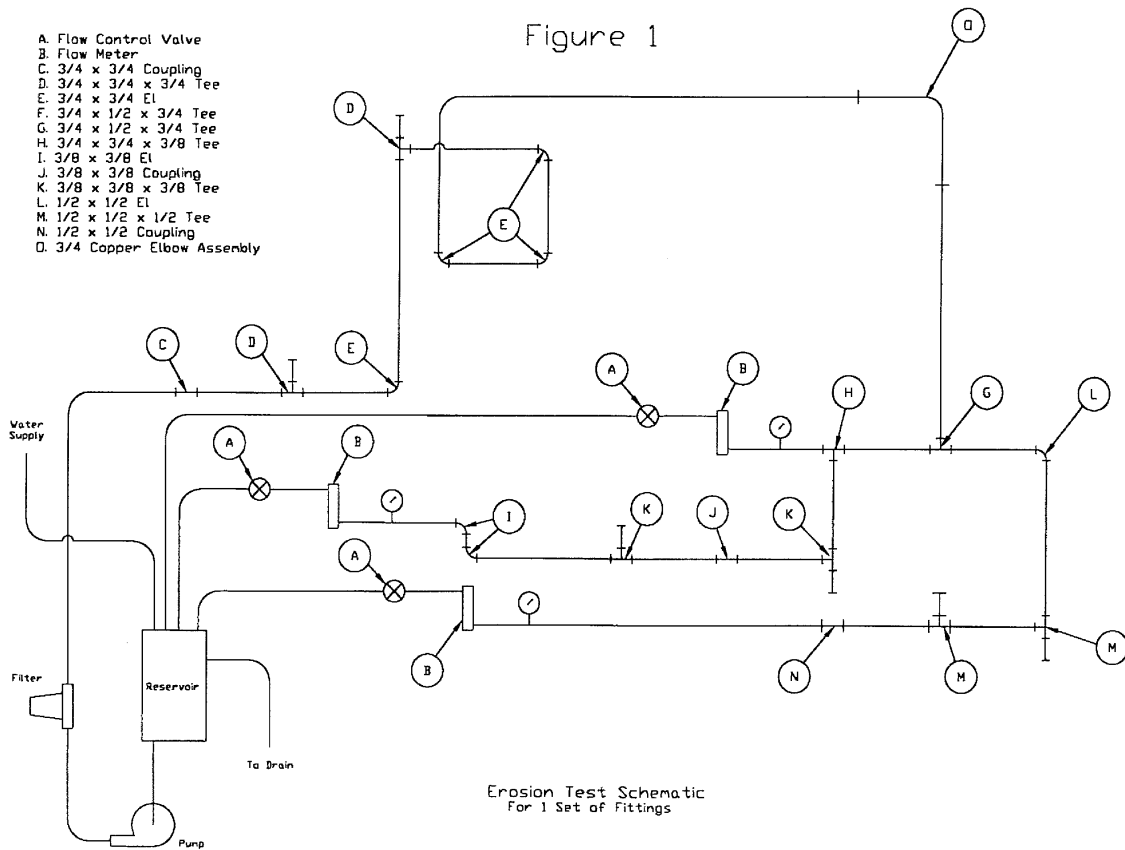
Each fitting shall be installed in PEX tube according to the manufacturer's instructions. The distance between any fitting and the next one must be at least 30 tube diameters except for the two $\frac{3}{8}$ " elbows. These two fittings should only have a distance of 2" between the insert portion of the fittings. If the PEX tubing is bent or curved, no fitting shall be closer than 30 tube diameters downstream of the bend. The direction of flow through each fitting shall be marked on the fitting. A schematic of a typical set-up for a fitting system is shown in Figure 1. Other arrangements could be used.

At a minimum, two tees, an elbow and a coupling of each size, from each material from each standard shall be tested. One of the tees will be tested with flow in the straight through direction and the other will be tested with flow coming in the straight through direction and out the branch. For the $\frac{3}{4}$ " size, 3 additional elbows will be installed in the system. One of these will be removed after 1 million gallons of water flow and the others will be removed at 2 and 3 million gallons of water flow. If other fittings are required for plumbing the system and they will experience the flows, they will be included in the test. They should be kept in "systems". With flow metering valves and flow meters it is possible to have flow through the $\frac{3}{4}$ " fittings first with some diverted to flow through $\frac{1}{2}$ " fittings and some diverted to flow through the $\frac{3}{8}$ " fittings.
